PERMITTING SETBACK REQUIREMENTS FOR WIND TURBINES IN CALIFORNIA

PIER INTERIM PROJECT REPORT

November 2006
CEC-500-2005-184

Scott Larwood and C. P. van Dam
California Wind Energy Collaborative
Davis, California
Contract No. 500-02-004
Work Authorization MR-017

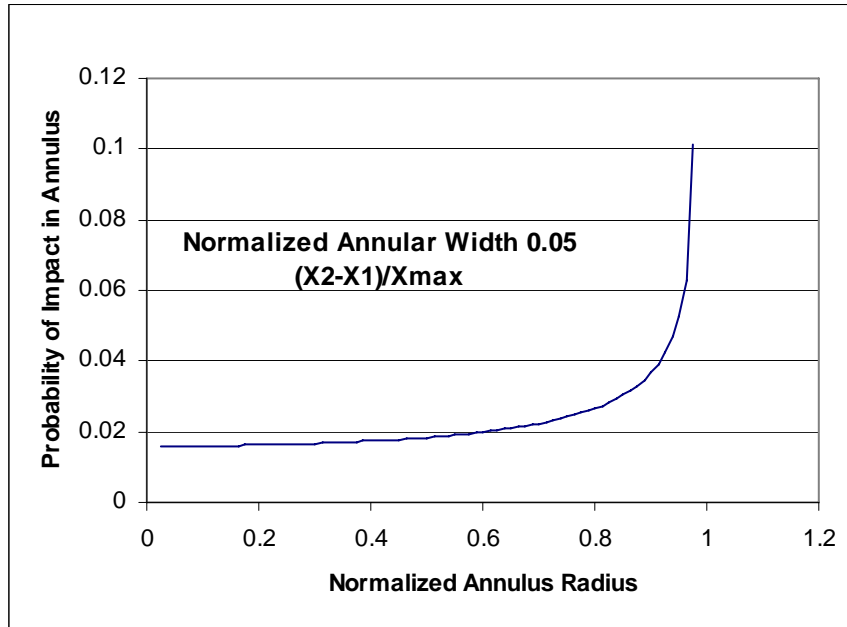
Figure 5. Probability of impact within an annular region

This relationship is plotted in Figure 5 for a normalized annular width of 0.05. Note that the relatively high probability of the fragment landing directly under the tower is not

shown. The nature of the equation results in an increasing probability of impact in the outermost annuli, due to a wide range of release angles that provide nearly the maximum range. However, the annular area increases with increasing radius.

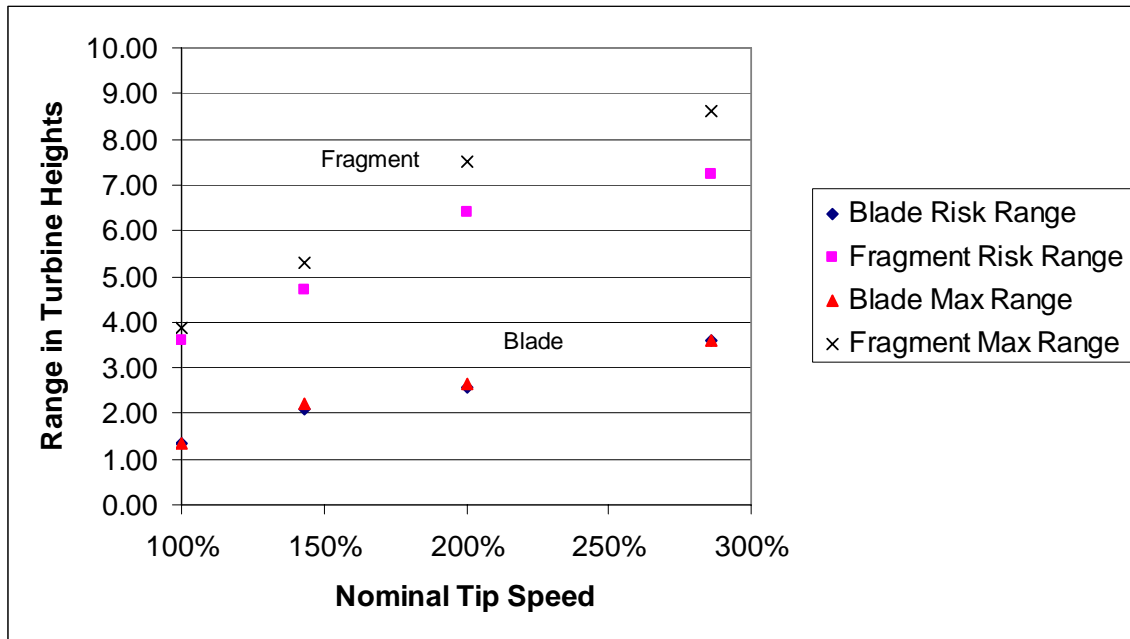
Figure 8. Throw distances in Sørensen conference paper with 1×10^{-4} probability risk range

Probabilities were only presented for the Project “K” turbine for a full 30 m blade throw and 10 m blade fragment throw. This turbine is of 1.5 to 2.0 MW size with a 60 m hub height. Release angle and wind speed were varied and multiple throws were calculated. The probabilities were presented as a function of tip speed. Results are shown in Figure 8, comparing the range with 10^{-4} probability (the “risk” range) to the maximum range.

The maximum ranges do not increase exponentially as would be predicted for a vacuum in Equation 4. This is the result of including the aerodynamic forces. Also, there is negligible difference for the full blade maximum range and range with 10^{-4} probability. This is not true for the fragment.
