PERMITTING SETBACK REQUIREMENTS FOR WIND TURBINES IN CALIFORNIA

PIER INTERIM PROJECT REPORT

November 2006
CEC-500-2005-184

Scott Larwood and C. P. van Dam
California Wind Energy Collaborative
Davis, California
Contract No. 500-02-004
Work Authorization MR-017

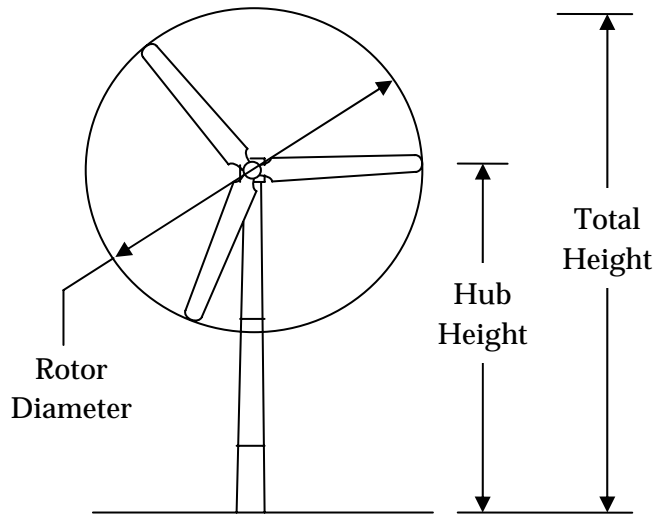
Figure 1. Wind turbine dimensions

Setbacks are established to minimize risk of damage or injury from component failure on property and personnel. The setbacks are usually a multiple of the total turbine height, from tower base to upper extreme point of the rotor (see Figure 1). Generally the setbacks can vary from 1.25 to 3 times the overall machine height. Larger setbacks are sometimes required for special areas. In contrast to these standards, counties in California with more rural development, such as Merced and San Joaquin, use building setbacks and do not distinguish wind turbines separately.

Table 2 compares setbacks for several of the counties organized by feature that the turbine must be displaced from, such as a property line. The distances are stated in multiples of overall turbine height (Figure 1). If a fixed distance is included with the multiple, then the maximum of the two values must be used for the setback.

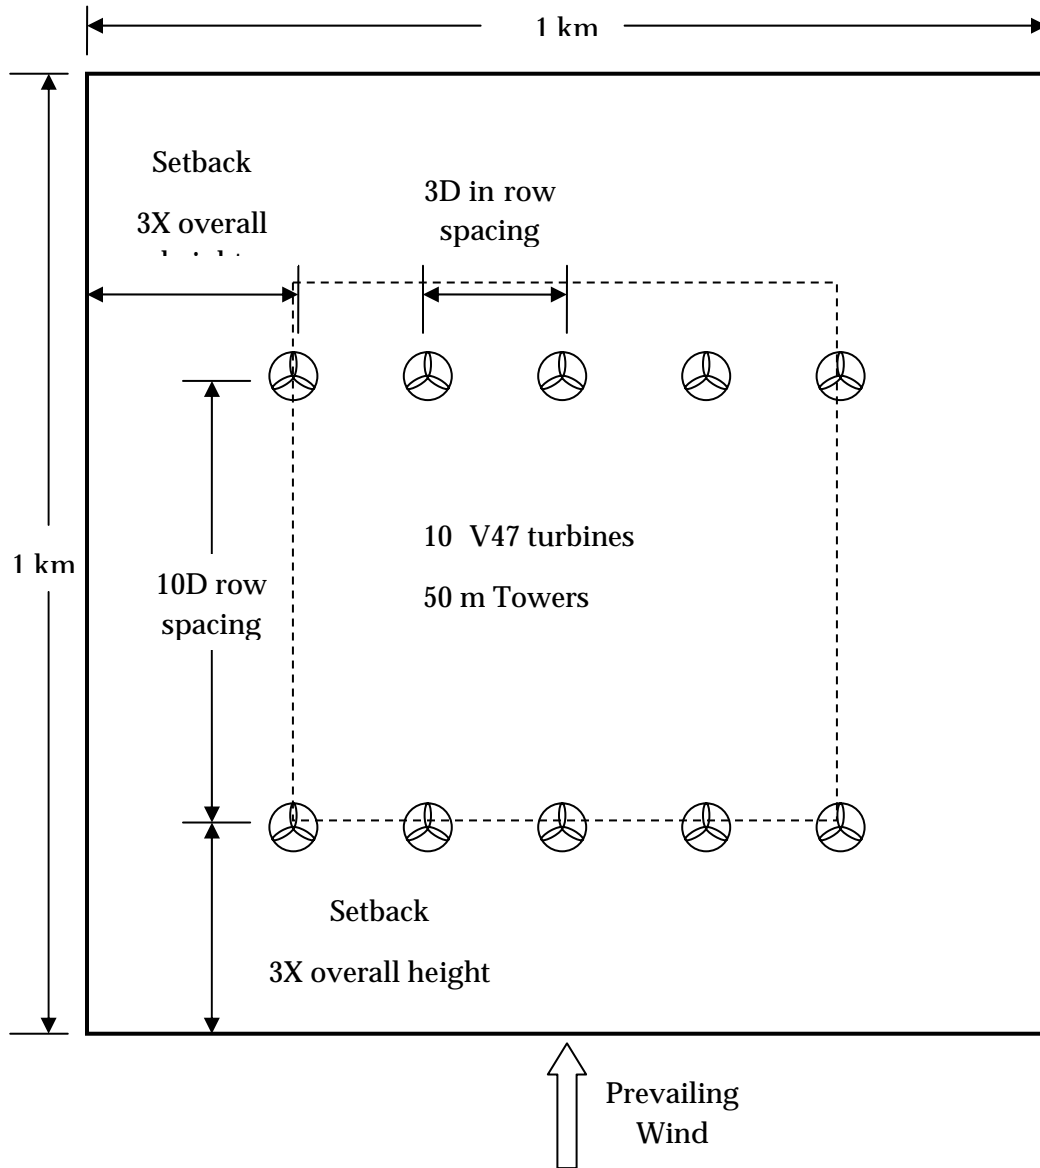
Figure 2. Layout for V-47 wind turbines based on setback requirement of three times total turbine height

The layouts are shown in Figure 2 and Figure 3, with shaded zones representing the setback areas. The overall height is the sum of the tower height plus half the rotor diameter.

For the V47 machine, the spacing requirements and setbacks allow for 10 machines with total rating of 6.6 MW. In contrast, the requirements allow only three GE 1.5 turbines with total rating of 4.5 MW. The crosswind spacing in this case would probably be reduced slightly. Downwind spacing requirements would force a second row of turbines off the parcel. The setback requirements for this example result in lower energy production with the application of larger, modern machines. The options available to a

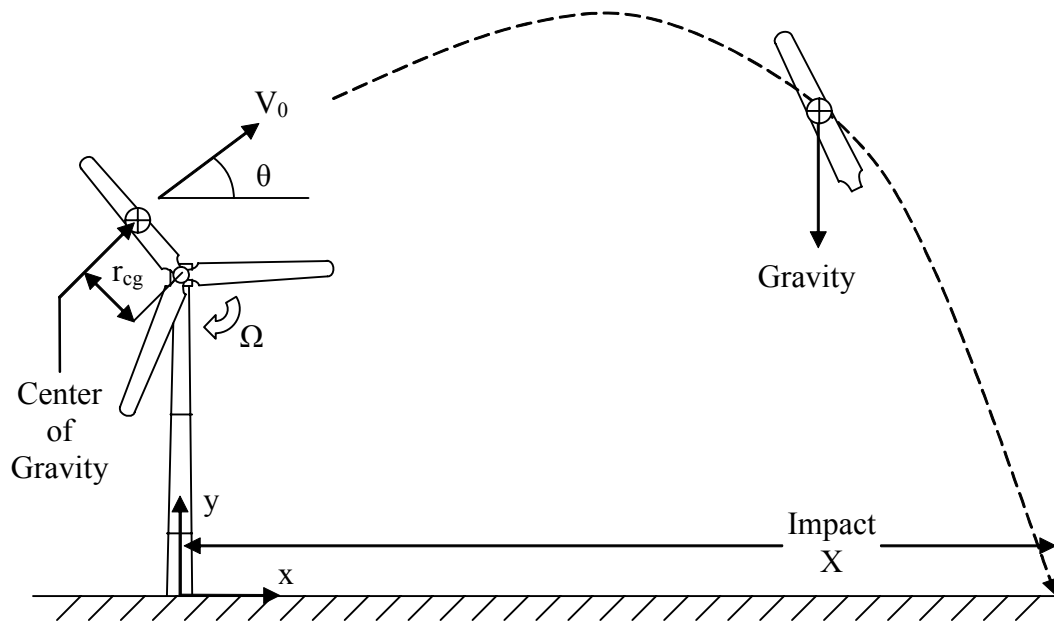
Figure 4. Rotor fragment schematic

Analysis of rotor failure uses methods of classical dynamics in order to describe the problem. Figure 4 is a representation of a rotor failure. If there is a rotor failure, either a fragment or the entire blade, the motion of the fragment is governed by specific forces. If the failure has taken place while the turbine is operating, the fragment has an initial velocity due to rotation, while in flight the motion is constrained by gravity and aerodynamic forces. The initial velocity of the rotor fragment is a function of the tip velocity, determined by Equation 1:

A simplified impact probability can be derived from Equation 3. Since this relationship is only valid for a ground release, only release angles of 0 to 180° (see Figure 4) result in movement away from the release point. Release angles of 180 to 360° result in impact at the base. The random release angle is assumed to have uniform distribution from 0° to 360°. Using methods of probability, the probability that a fragment will fall within an annulus that is less than the maximum range is given by Equation 5.

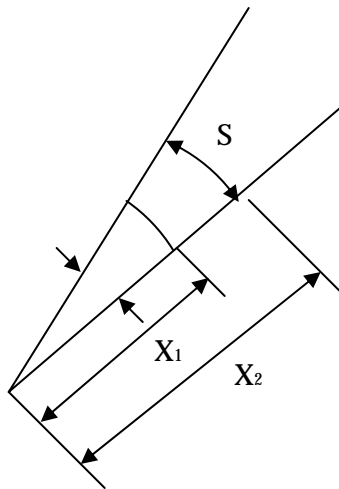
Figure 6. Target annular sector

We next assume that the target is an annular sector, as in Figure 6.

In order to make the sector size roughly equal throughout the ballistic range, we set the outer arc length (S) equal to the annular width, given by Equation 6:

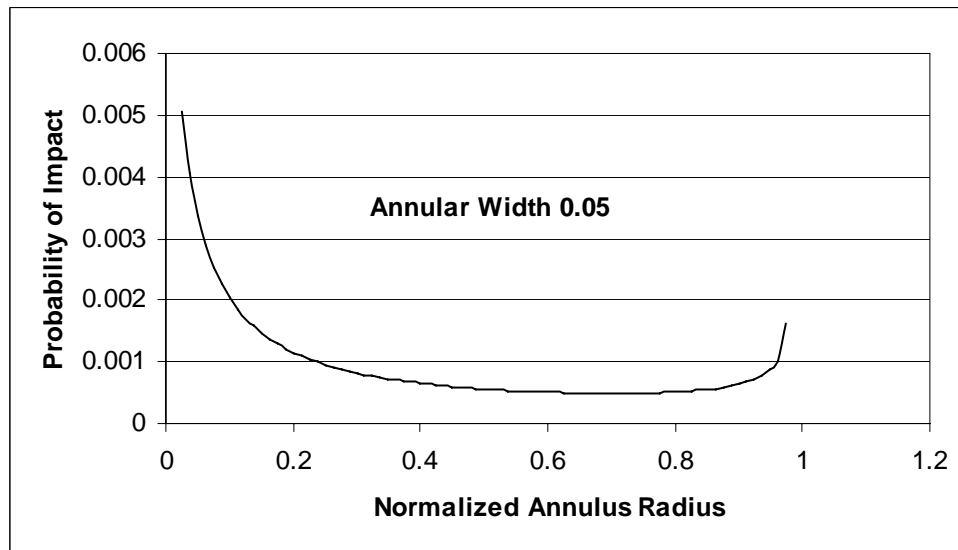
Figure 7. Probability of impact within annular sector

This relationship is plotted in Figure 7. This simplified model shows a peak in probability near the tower base, and then a relatively constant probability until the probability rises again near the maximum range. This behavior is similar to more complex models incorporating aerodynamics. The peak at maximum range places a constraint on the overall hazard and acceptable setback distances.

The probability of impact is weighted by area (per square meter), and assumes equal distributions in all directions. Probability distributions showed peaks near the tower and at the maximum range, similar to the results of the simplified model in Figure 7. The probability of impact was then a function of the target and fragment size. Macqueen reasoned that the rotor fragments would be large compared to target, making the probability independent of target size; however this would not be the case with a busy roadway, with many targets over a large area.

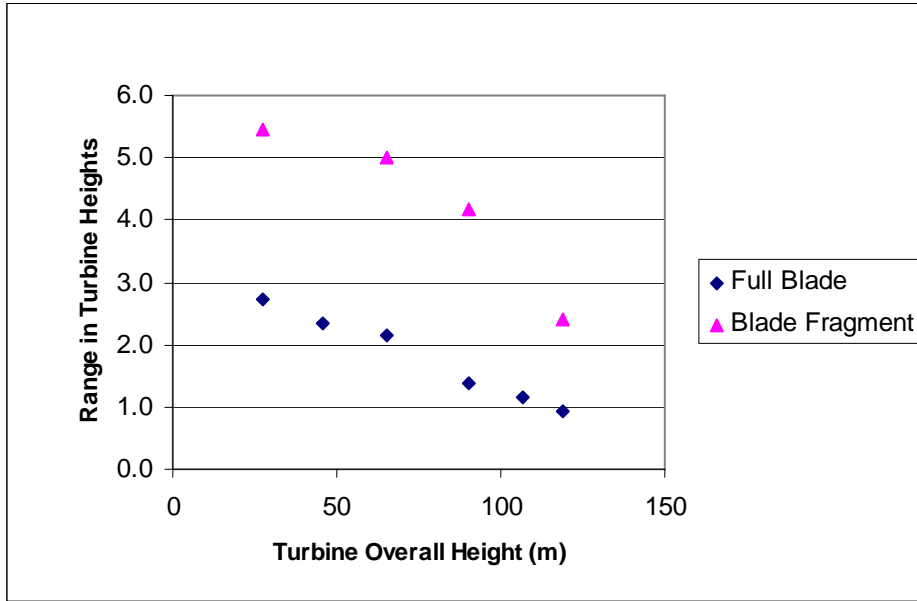
Studies of example turbines were performed in all the analyses discussed previously. A comparison is shown below in Figure 9. The maximum attainable lateral throw distance, normalized by overall turbine height, for a failure at nominal operating conditions is shown for the various analyses. The results show the drop in the normalized maximum throw distance with increasing turbine size.

Figure 9. Comparison of rotor fragment analyses for maximum range at nominal operating conditions

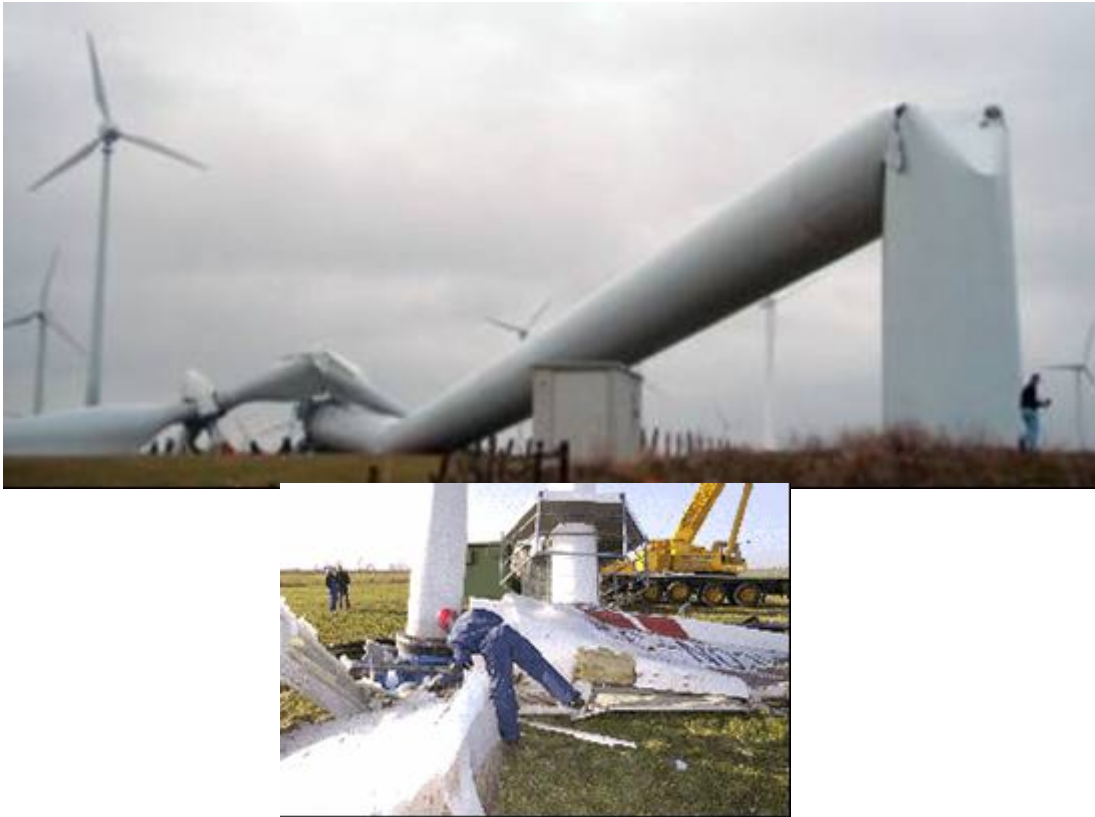
Fig. 2.1: Two examples of incidents that pose possible danger to the surrounding area.

In many cases it appeared difficult to indicate exactly whether a turbine had indeed lost parts as in Fig. 2.1, or was just heavily damaged as in Fig. 2.2. The final results from the selection of risk involved incidents are given in Table 2.2. The total can be seen in Table 2.3. This table includes the total number of operating years for each type. This number is obtained by summing the number of turbines in operation per year over all the years.

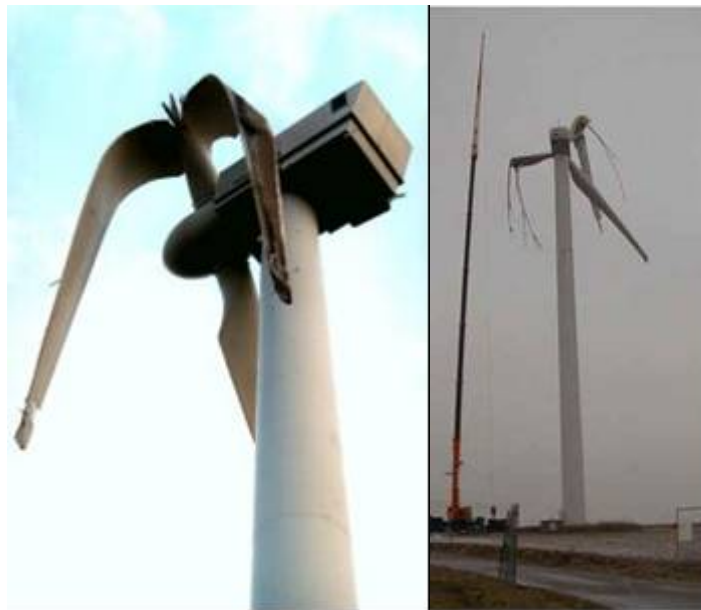
- Most incidents are poorly documented, and the actual number of risk involved incidents cannot be determined for certain. EMD uses codes to indicate which component failed, the reason for failure, and whether parts were thrown from the turbine. From the codes it is difficult to determine the size of the thrown object, the distance thrown, and the order of events. In some cases this information is included in the comments. Between 1993 and 2000 the code was expanded. Between 1984 and 1992, the code was severely restricted. It was seldom even noted whether a compromised turbine had done damage to the surrounding area. This made it possible for a turbine that had a complete failure and lost many parts (see Fig. 2.1) to be reported exactly like a turbine that had a complete failure and posed no risk to the surrounding area (see Fig. 2.2).

Fig. 2.2: Two examples of turbines that failed, but caused no danger to their surroundings.

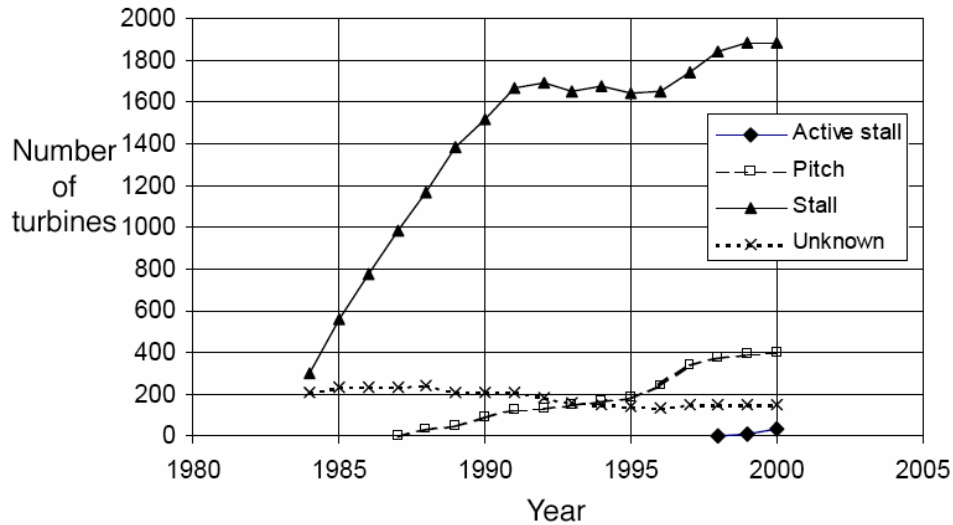
The turbine population from 1984 through 2000, as provided by EMD, is separated into the different types. The results are presented in Fig. 2.3. At the end of the year 2000 the total turbine population reached about 2900 turbines. The total number of operating years reached almost 30,000. By far the most turbines are stall regulated turbines.

Fig. 2.3: Number of wind turbines in the EMD database, separated by type.

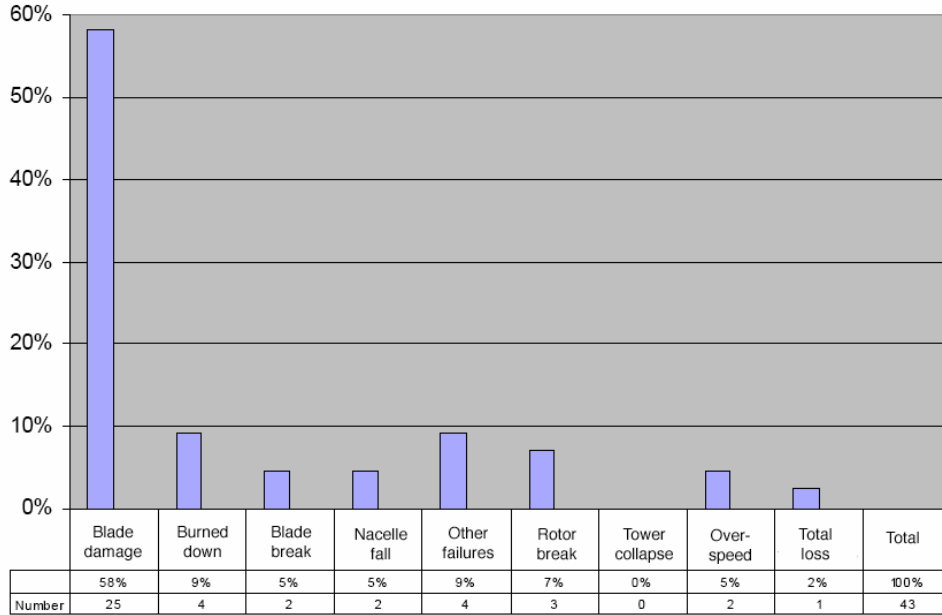
The 43 cases of turbine damage from the WMEP database are arranged by type of damage. The results are presented in Figure 3.1.

Fig. 3.1: Type of damage for 43 cases involving serious damage.

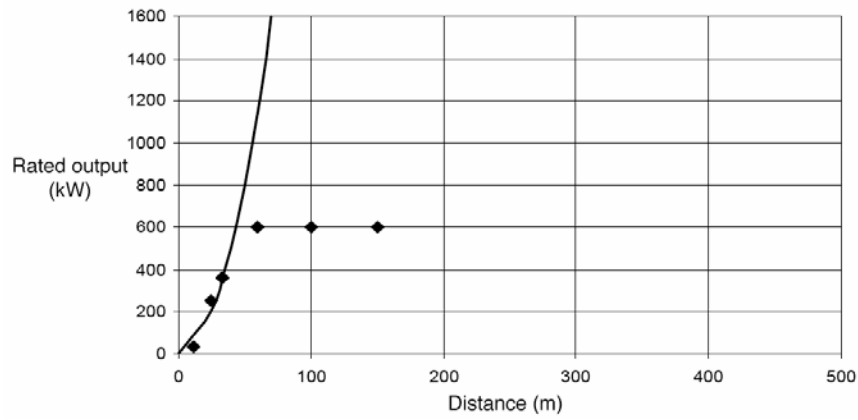
The results of the analyses are presented in Figures 5.1 through 5.4. In these figures, one for each type of incident, the reported throw distance is presented (x axis) as a function of the rated power (y axis). The curves in each graph relate the approximate rotor diameter associated with corresponding rated power level. The curves are added to put the throw distances in perspective.

Fig. 5.1: Throw distance of entire blades as a function of the rated power output, the drawn line gives the rotor diameter.

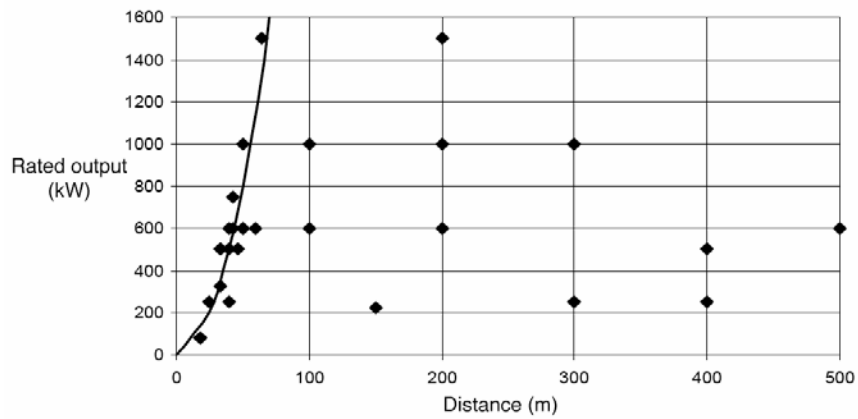
Fig. 5.2: Throw distance of tips and small blade pieces as a function of the rated power output, the drawn line gives the rotor diameter.

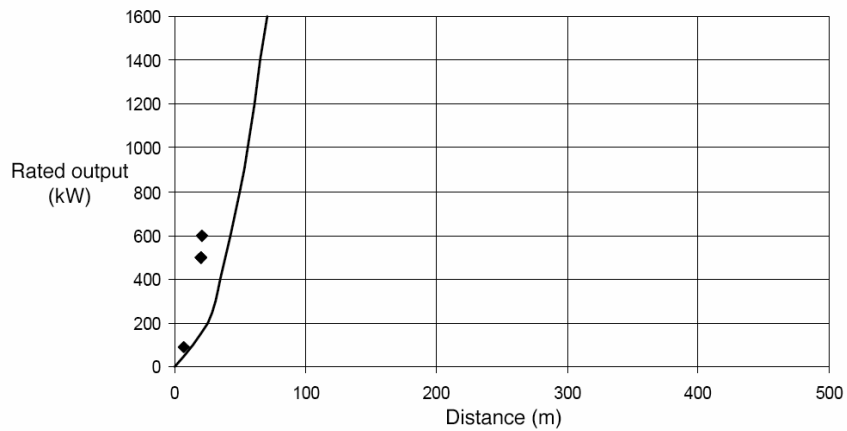
Fig. 5.3: Throw distance due to fall of nacelles and rotors, as a function of the rated power output, the drawn line gives the rotor diameter.

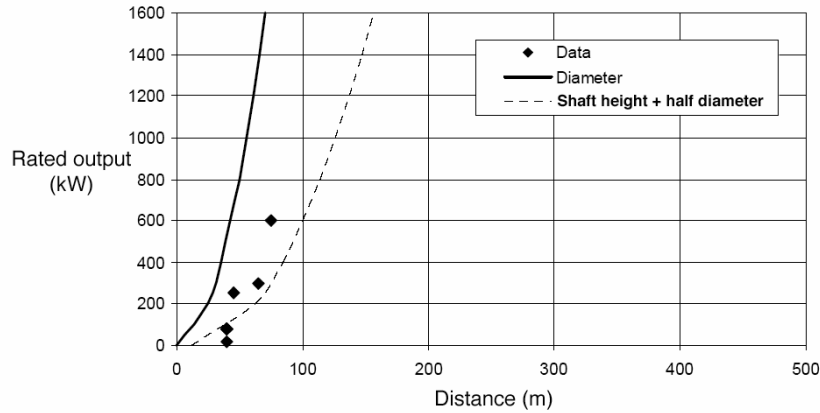
Fig. 5.4: Throw distance due to tower collapse as a function of the rated power output, the drawn line gives the rotor diameter. The dotted line gives the shaft height plus rotor radius (half diameter).
